**REMEDIAL  
INVESTIGATION  
REPORT AND REMDIAL  
ACTION WORK PLAN**

Former Camden Laboratories  
Property

1667 Davis Street  
City of Camden  
Camden County, New Jersey  
Block 1392  
Lot 33

0230198.01  
Camden Redevelopment  
Agency  
October 2019

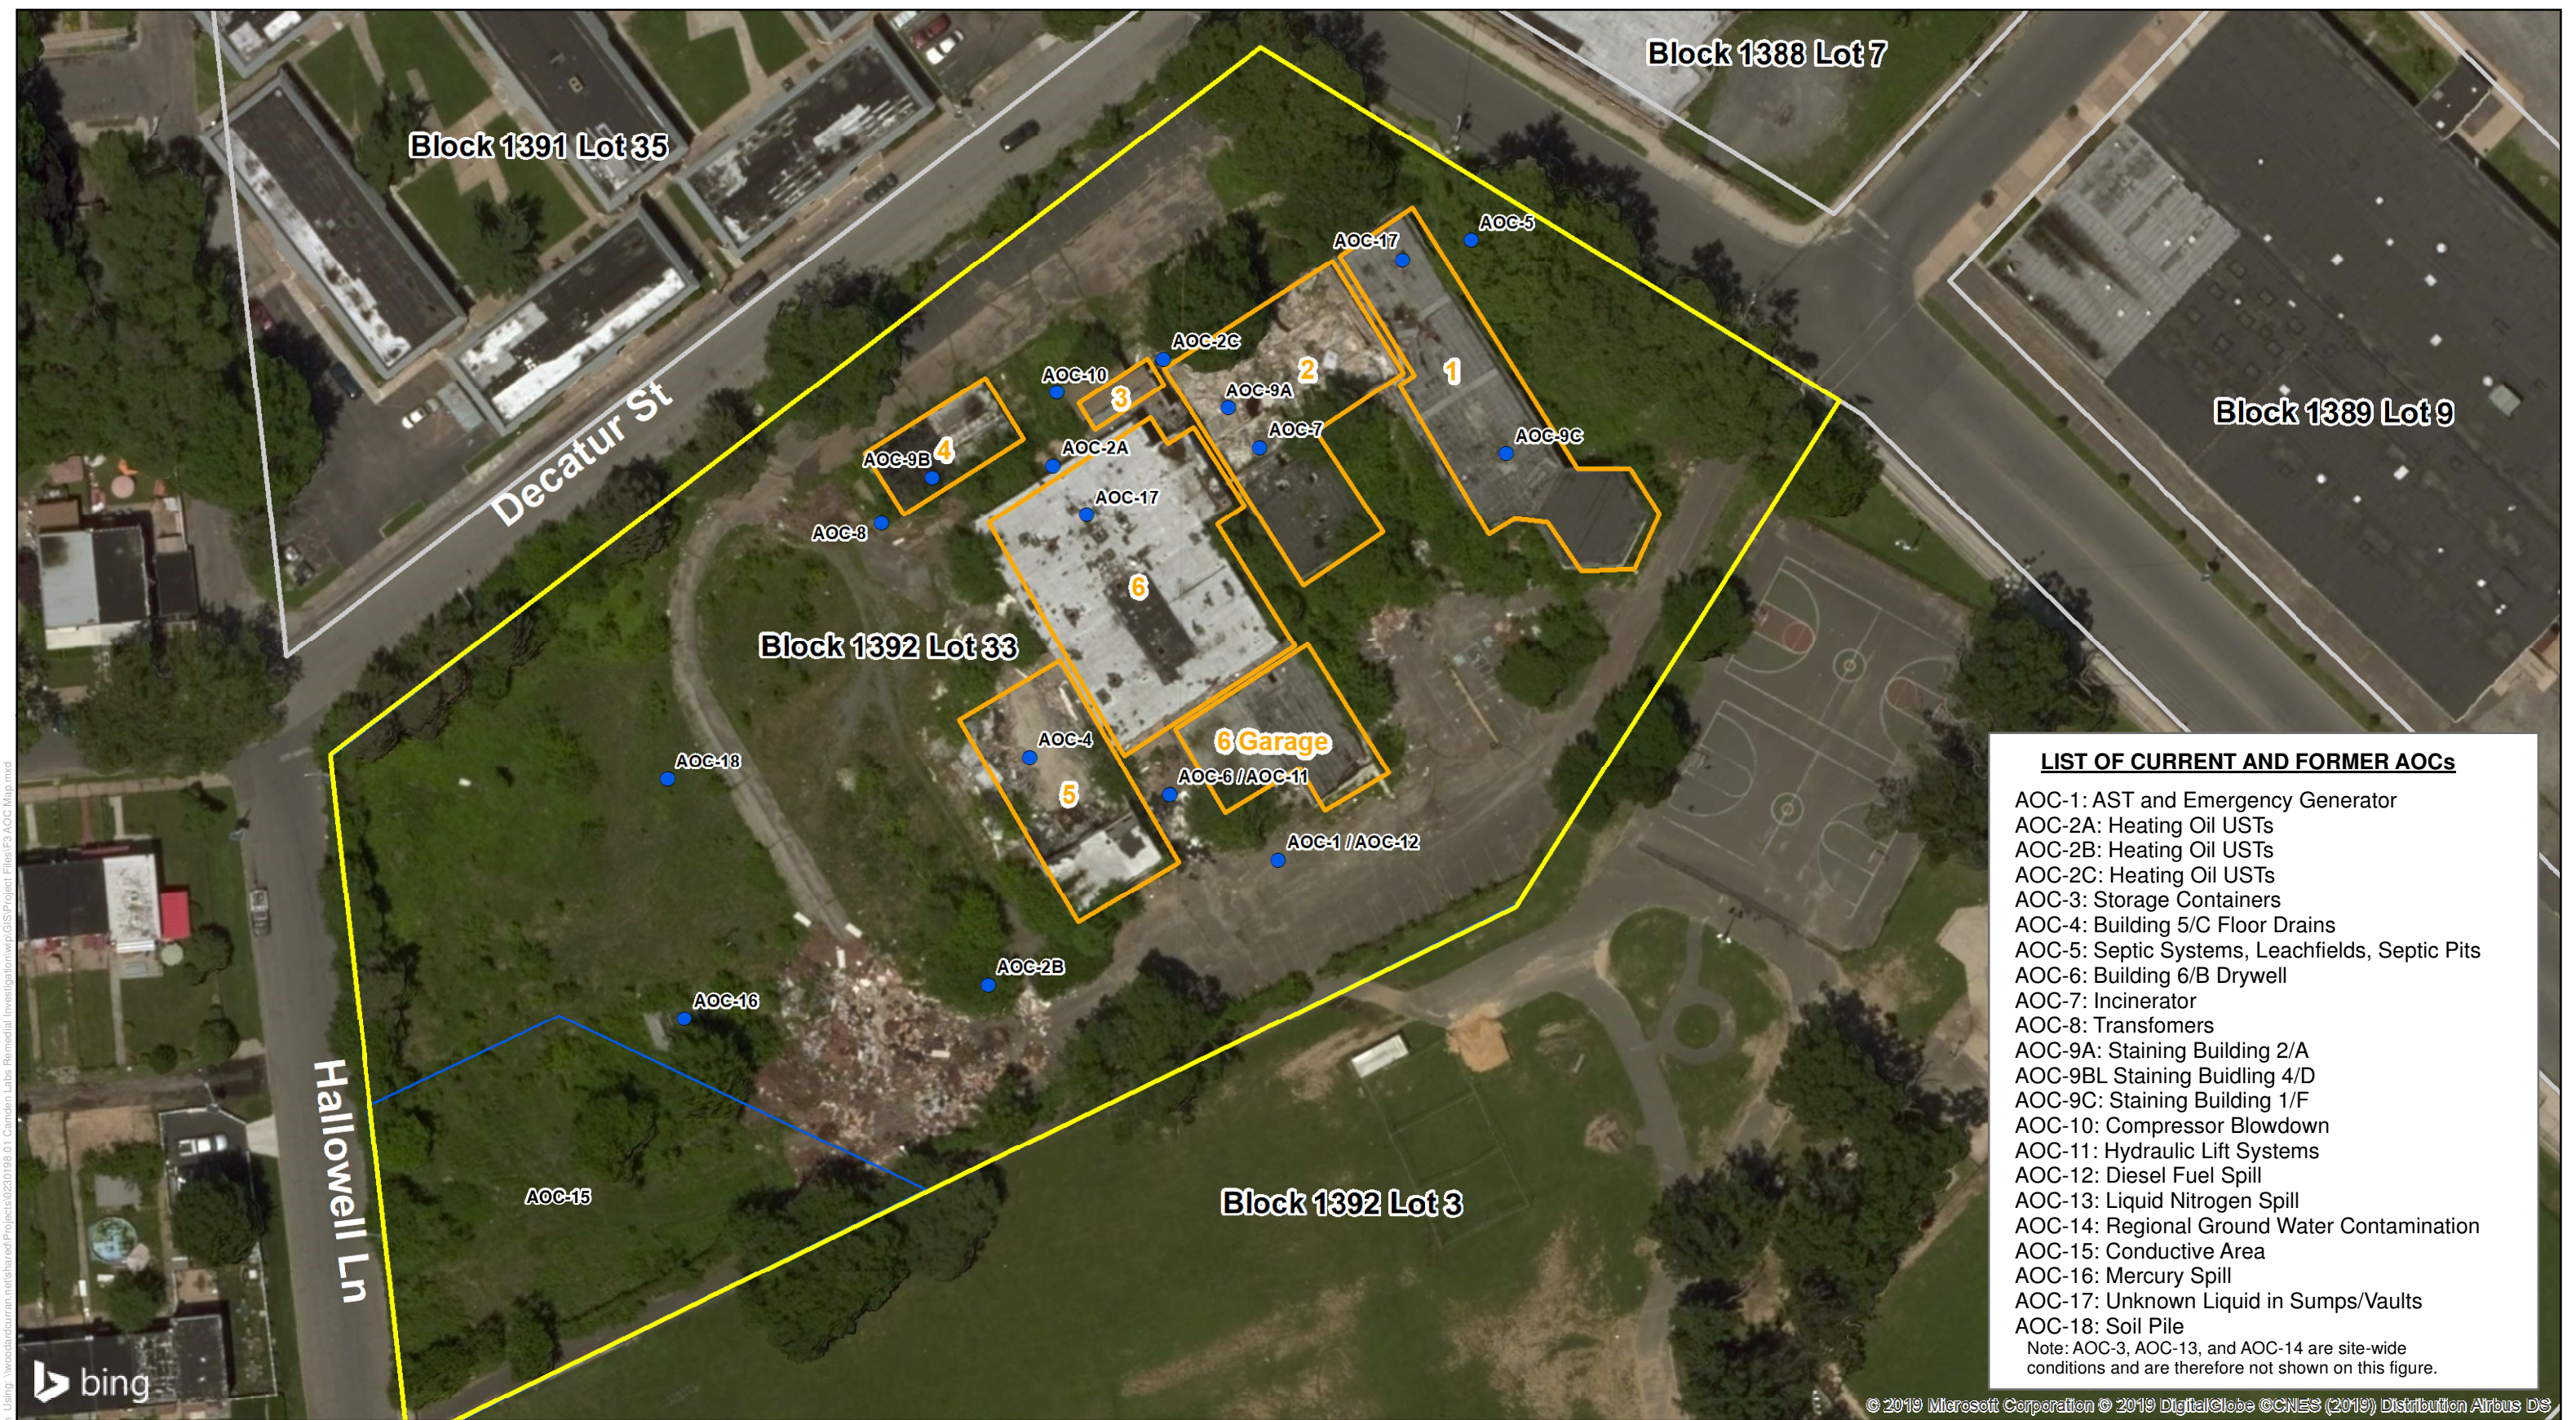
**Areas of Concern**

- LIST OF CURRENT AND FORMER AOCs**
- AOC-1: AST and Emergency Generator
  - AOC-2A: Heating Oil USTs
  - AOC-2B: Heating Oil USTs
  - AOC-2C: Heating Oil USTs
  - AOC-3: Storage Containers
  - AOC-4: Building 5/C Floor Drains
  - AOC-5: Septic Systems, Leachfields, Septic Pits
  - AOC-6: Building 6/B Drywell
  - AOC-7: Incinerator
  - AOC-8: Transformers
  - AOC-9A: Staining Building 2/A
  - AOC-9BL Staining Building 4/D
  - AOC-9C: Staining Building 1/F
  - AOC-10: Compressor Blowdown
  - AOC-11: Hydraulic Lift Systems
  - AOC-12: Diesel Fuel Spill
  - AOC-13: Liquid Nitrogen Spill
  - AOC-14: Regional Ground Water Contamination
  - AOC-15: Conductive Area
  - AOC-16: Mercury Spill
  - AOC-17: Unknown Liquid in Sumps/Vaults
  - AOC-18: Soil Pile
- Note: AOC-3, AOC-13, and AOC-14 are site-wide conditions and are therefore not shown on this figure.

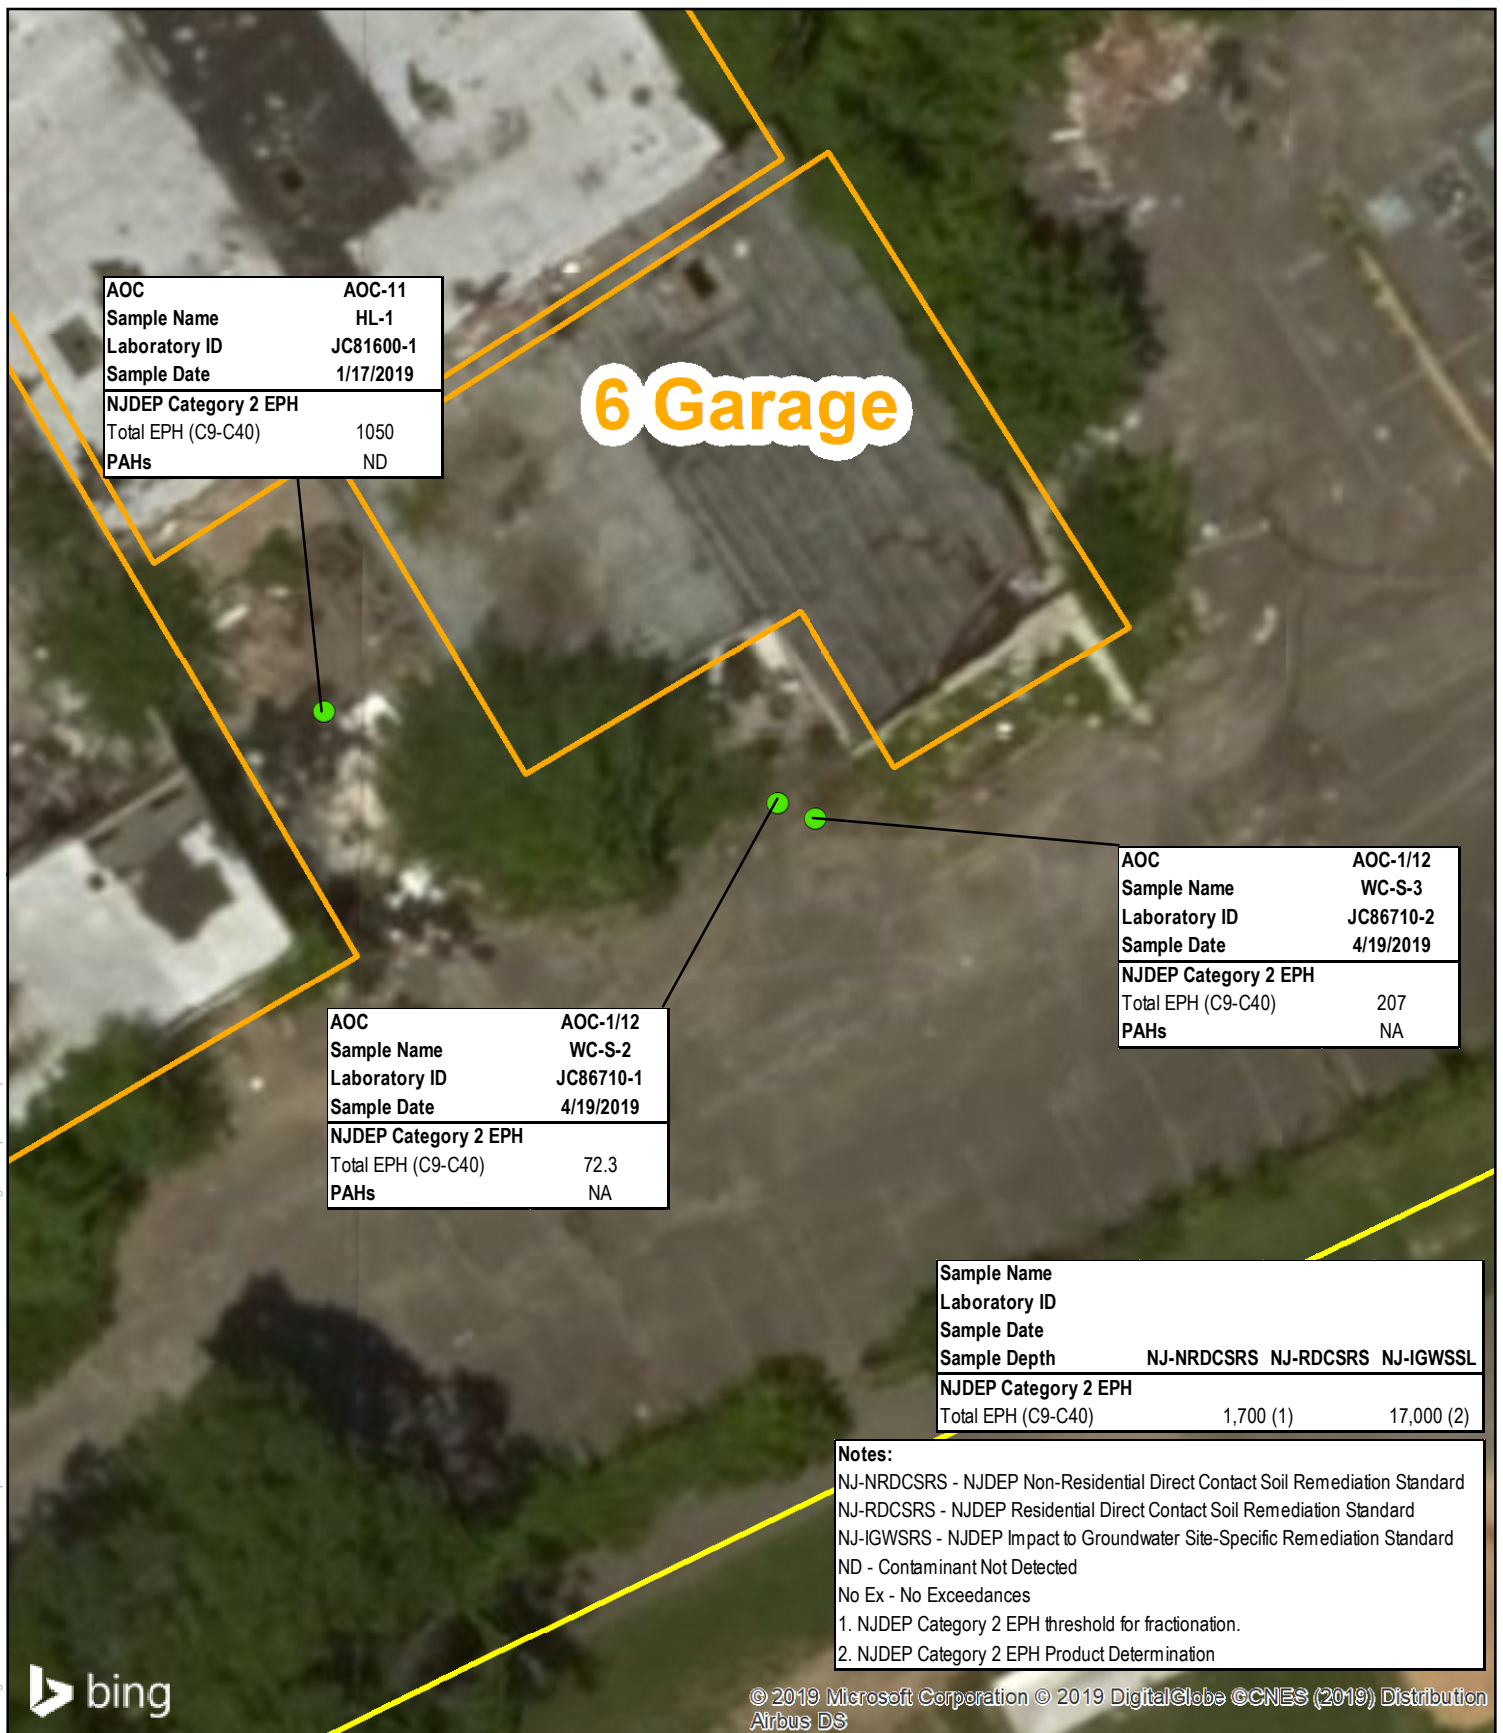
AOC	AOC-11
Sample Name	HL-1
Laboratory ID	JC81600-1
Sample Date	1/17/2019
<b>NJDEP Category 2 EPH</b>	
Total EPH (C9-C40)	1050
PAHs	ND

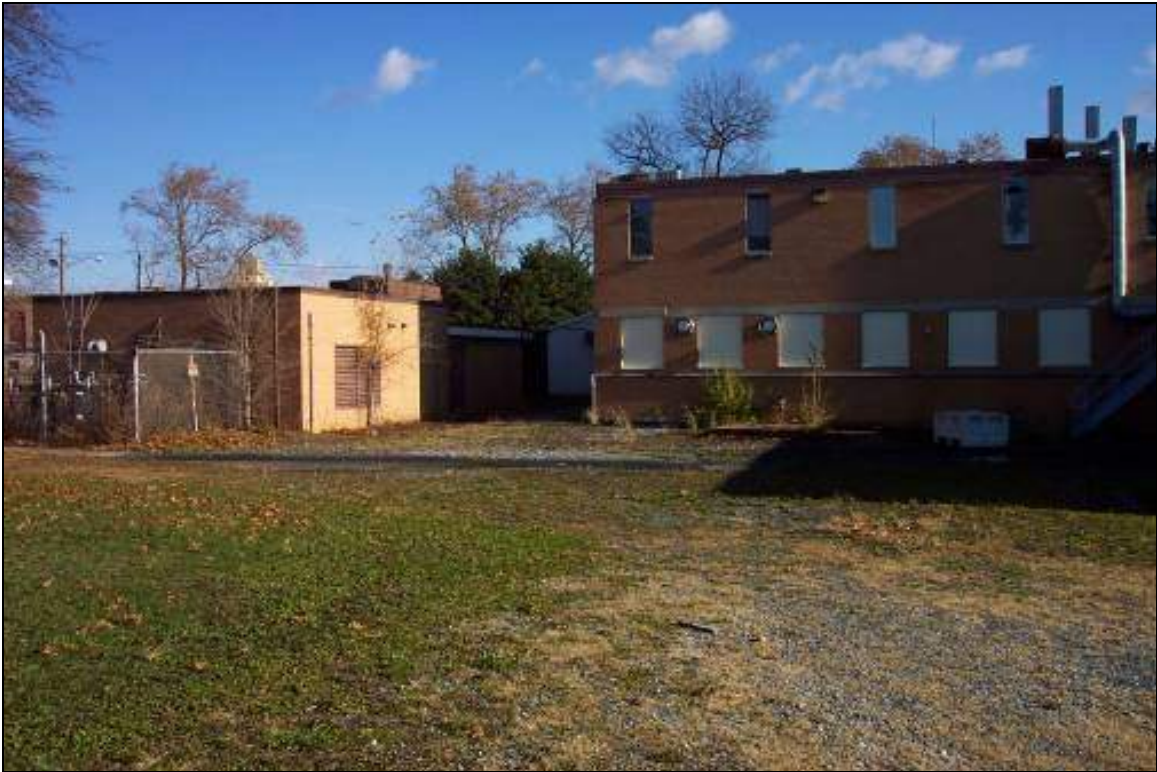
View of Buildings C and D

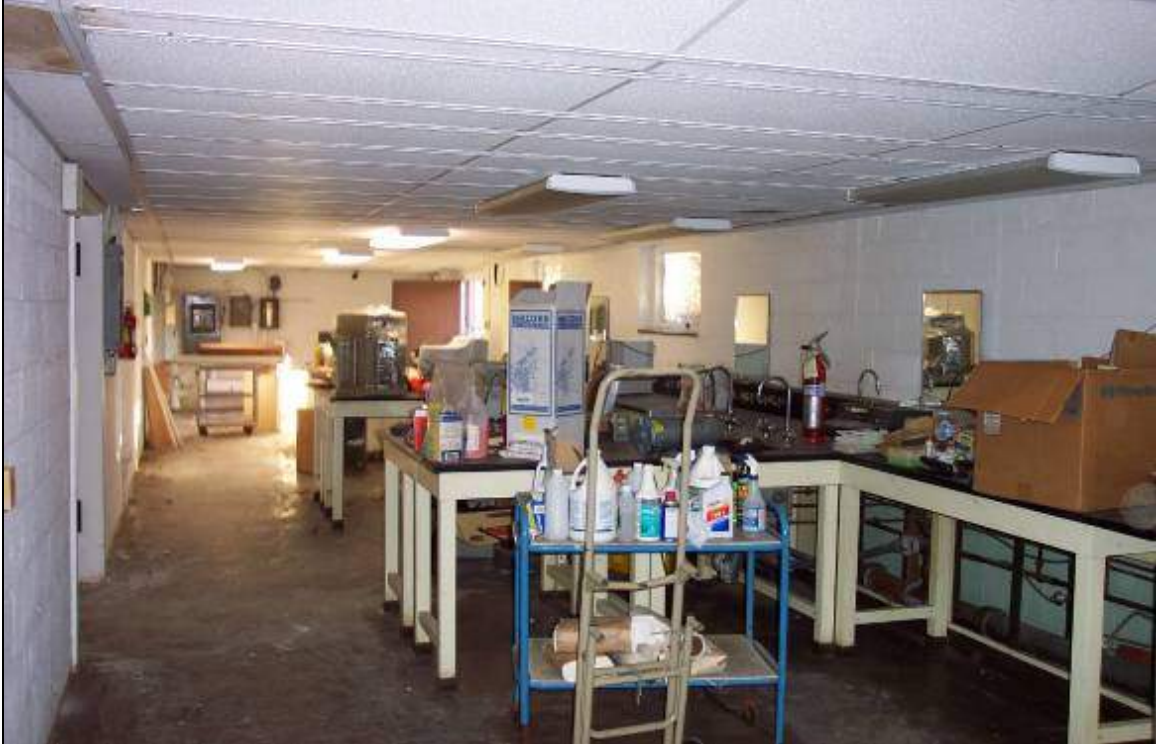
View of cleaning supplies located in the first floor laboratories of Building A. No leaking or staining observed.

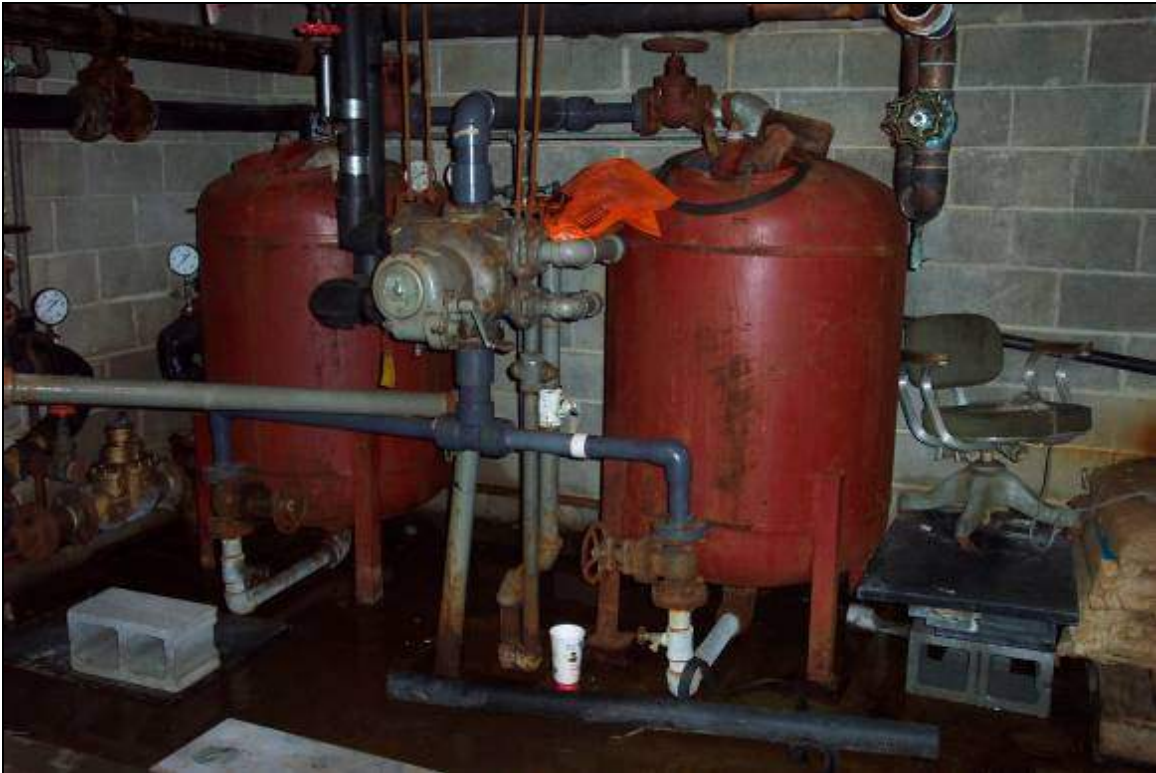
View of water filter system located in the basement of Building A. Water was visible beneath the filters due to ruptured pipes.

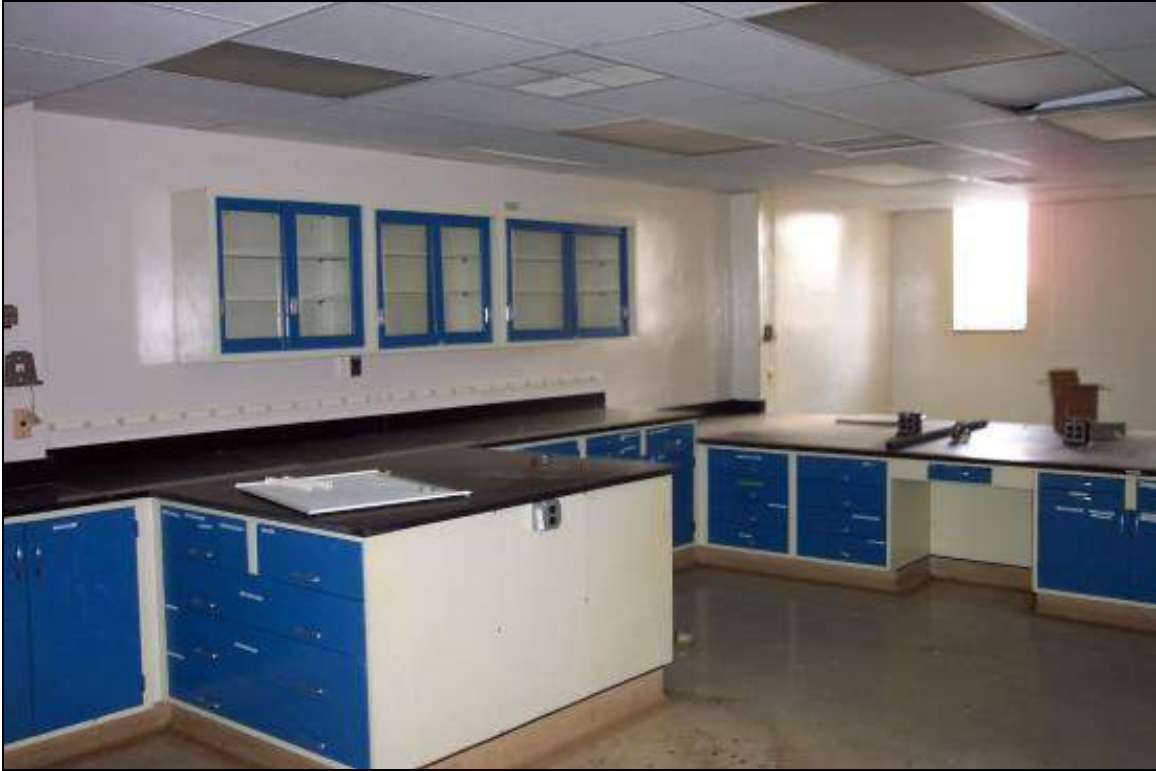
View of second floor lab in Building B

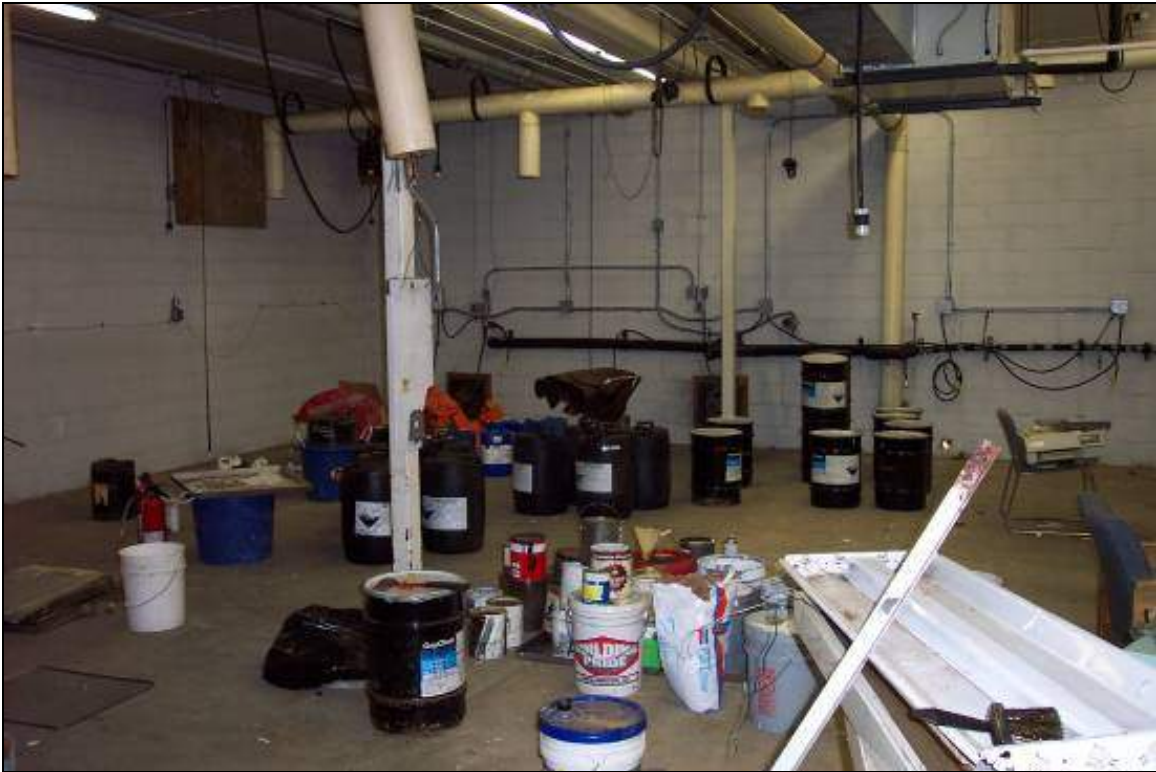
View of freezer room of Building B. Four (4) containers of muriatic acid, five (5) containers of caustic soda and several empty five (5) gallon containers were noted. No staining was observed.

At the time of CMX's 2008 PA inspection, several storage containers were observed within the former freezer room of Building B including four 55-gallon drums of muriatic acid and five 55-gallon drums of caustic soda. Several empty 55-gallon drums, five-gallon containers and a one-gallon paint container were also observed within the room. No staining was noted on the concrete beneath the drums. The floors were in good condition, no apparent cracks or migration pathways were noted. Based on this information, CMX recommended no further investigation of this AOC. These findings were presented to the NJDEP in the August 2008 PA/SI Report.

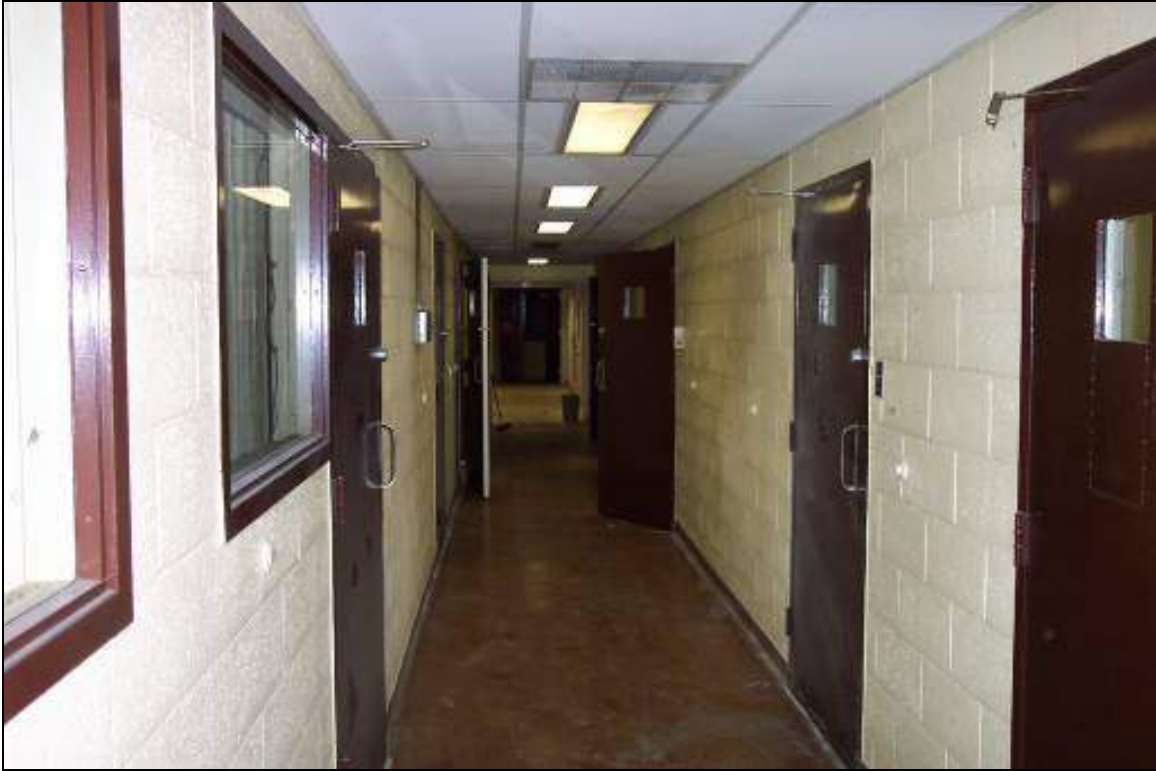
View of animal quarters located on the first floor of Building B

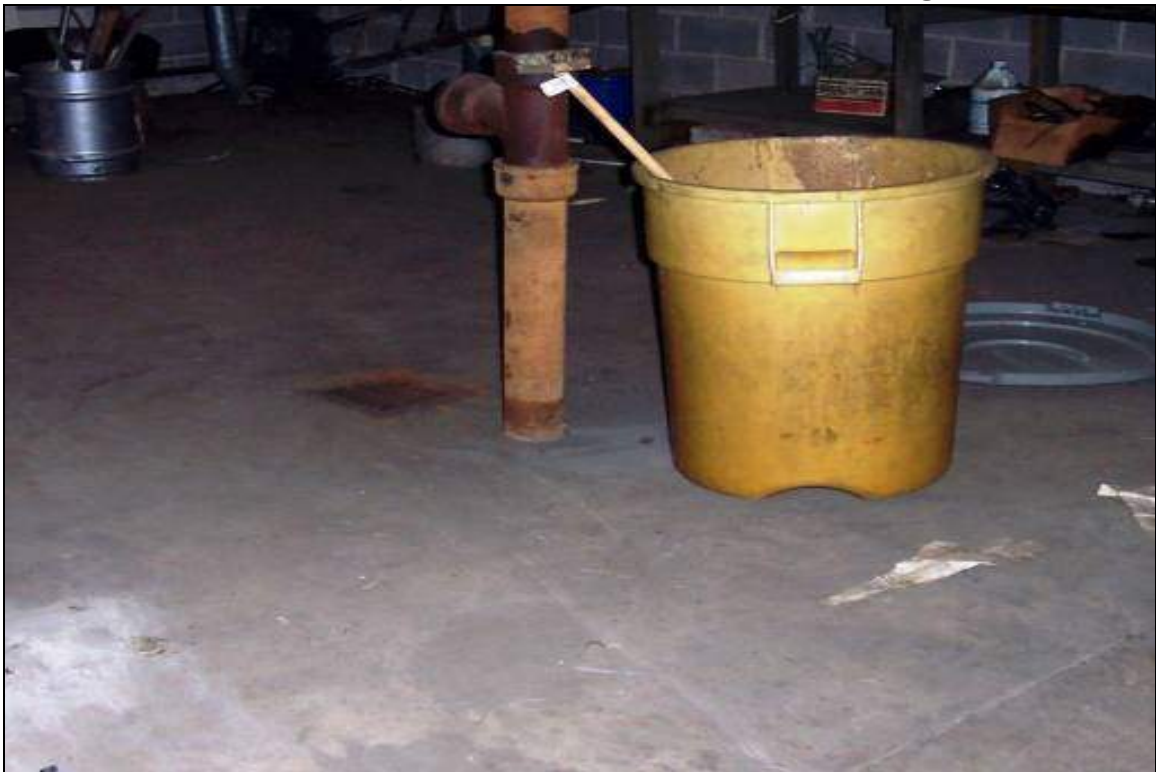
View of boiler room in Building B. No staining noted in the area of the floor drain.

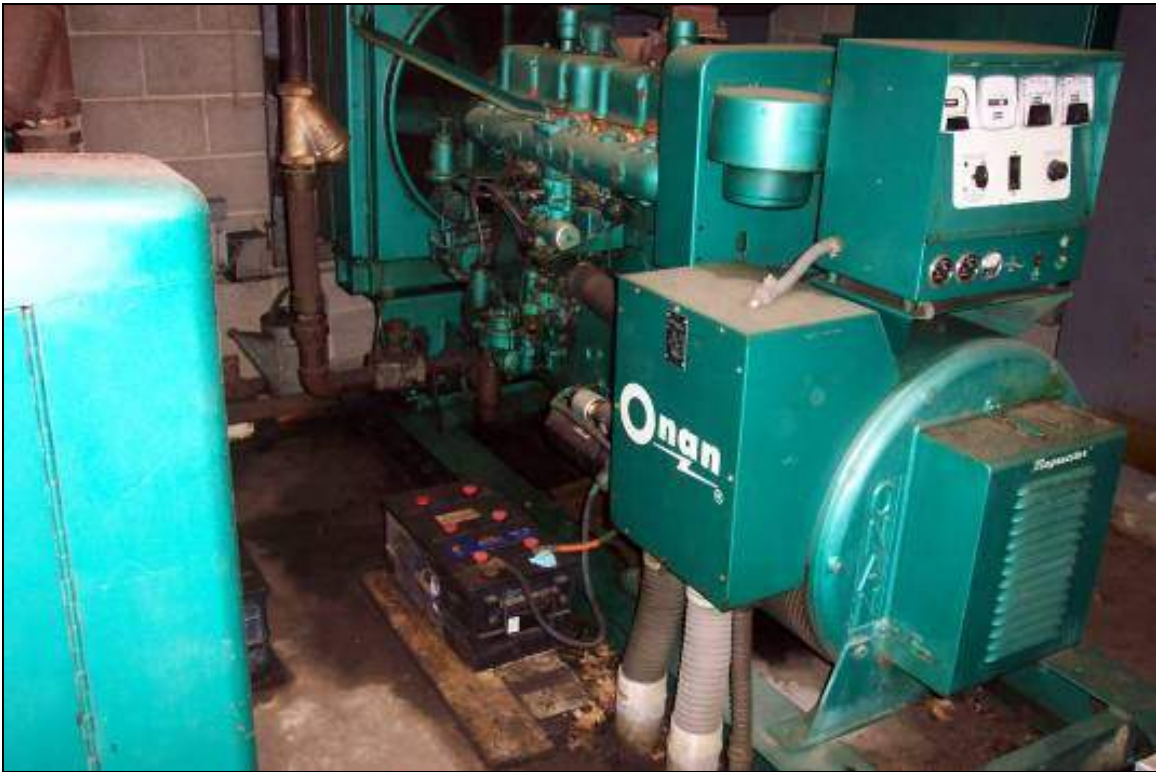
Heavy staining of the concrete surface was noted beneath the generators; however, the floors appeared to be in good condition and no apparent cracks or migration pathways were noted. No floor drains were noted in this building. Based on these findings, CMX recommended no further investigation for this AOC. These findings were presented to the NJDEP in the August 2008 PA/SI Report prepared by CMX.

View of emergency generators located in Building D. Staining observed beneath the generators.

Based on the information presented above, no further investigation is recommended for this AOC.

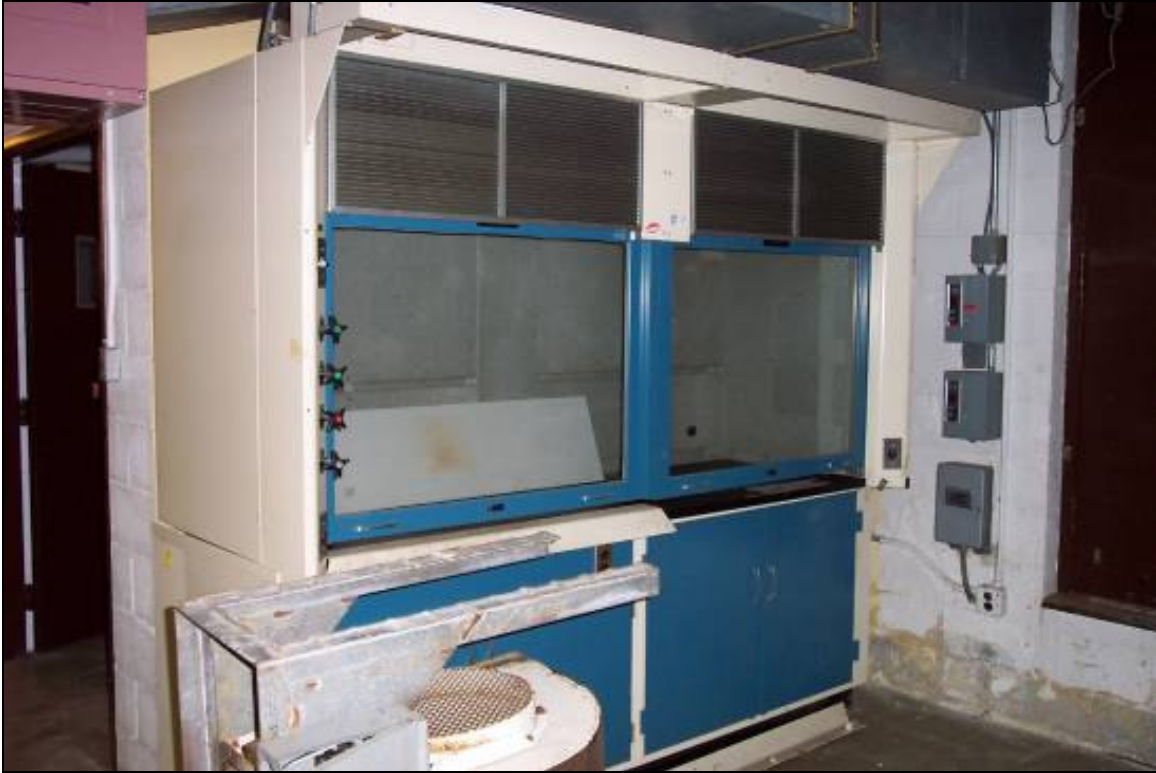
View of laboratory vent hood located in the ground floor of Building F

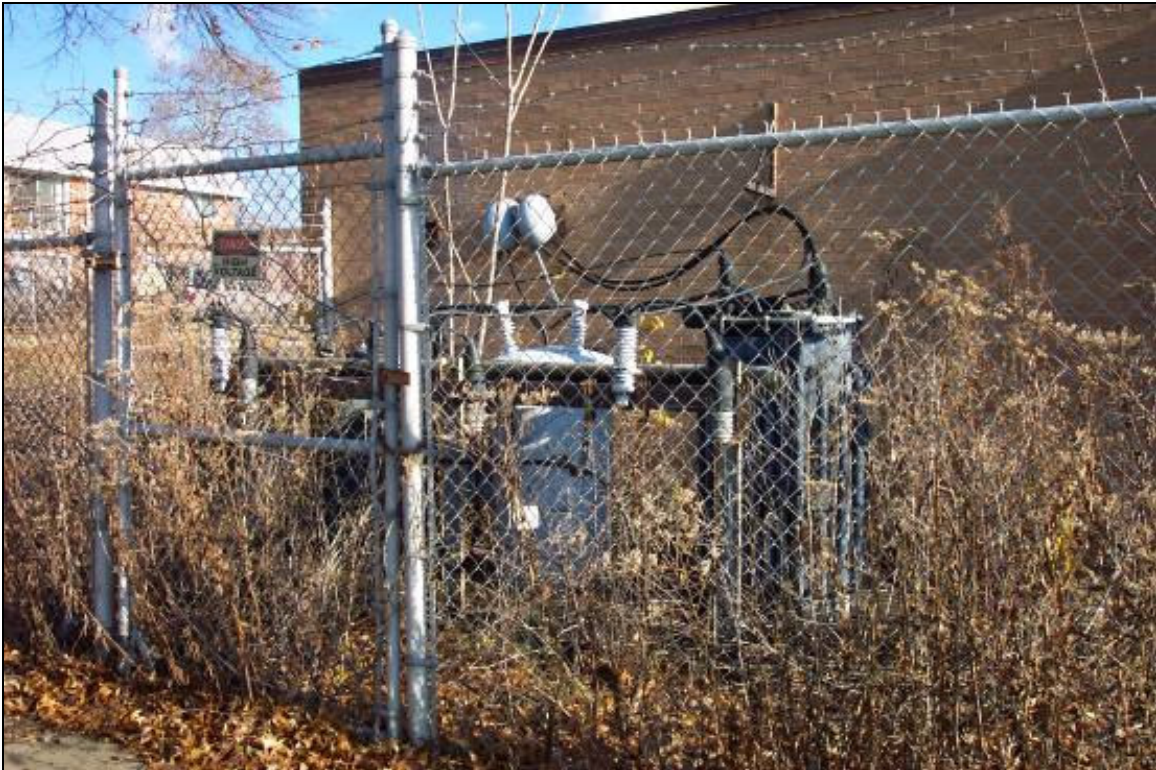
Two (2) electric transformers were observed at the west exterior of the power house (Building 4/D). Previous reports prepared by other indicate the transformers were dry-type, air-cooled equipment and did not contain oil. In addition, one (1) pole mounted electrical transformer was located along Davis Street. At the time of CMX's 2008 PA inspection, the transformers were in fair condition and situated on concrete. No staining or stressed vegetation was observed at the ground surface beneath any of these transformers. Based on these findings, CMX recommended no further investigation for this AOC. These findings were presented to the NJDEP in the August 2008 PA/SI Report.

View of electric transformers located adjacent to the west of Building D. Staining could not be determined due to overgrown vegetation.

Based on the information presented above, no further investigation is recommended for this AOC.

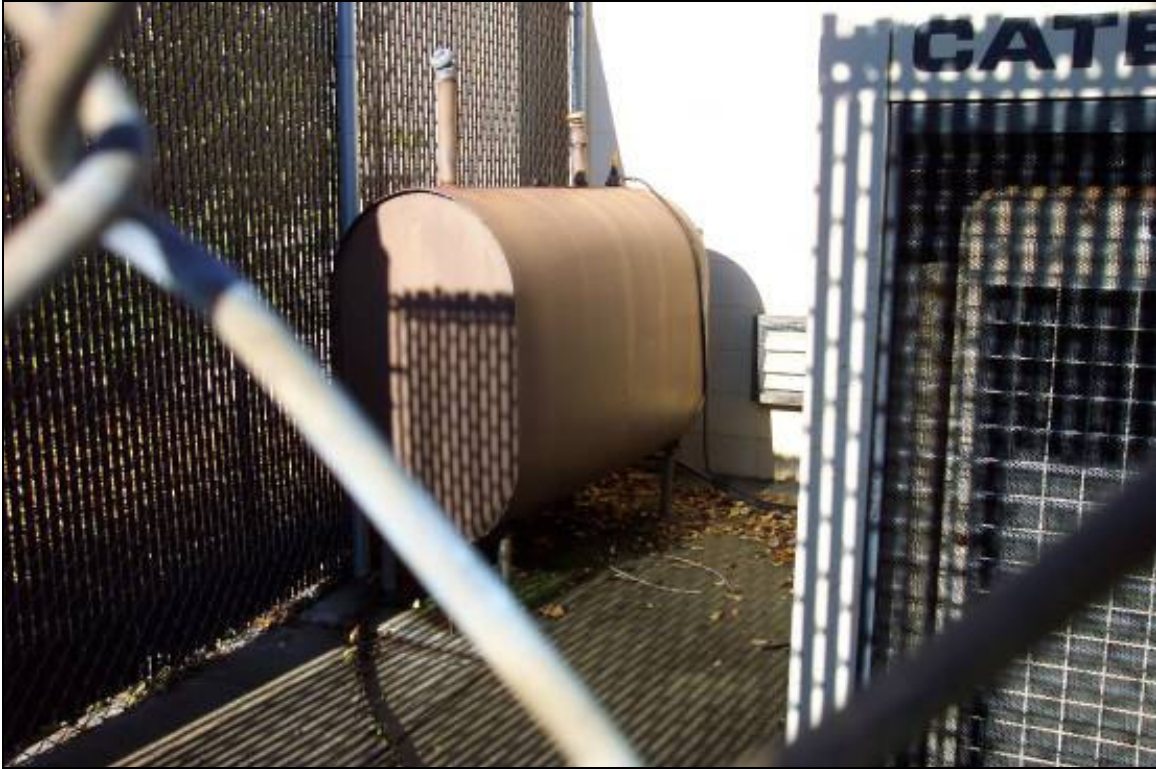
One (1) 275-gallon diesel aboveground storage tank (AST) was historically located south of Building 6/B. The AST was used to service an outdoor emergency generator. The AST was reportedly vandalized resulting in a diesel fuel spill to the surface. As a result, the NJDEP was contacted and the spill was assigned Case No. 97-02-21-1440-39. During the 2007 site inspection, CMX noted that the AST and generator were located on a concrete slab surrounded by asphalt. Based on this information, CMX recommended no further investigation of this AOC. These findings were presented to the NJDEP in the August 2008 PA/SI Report.

View of empty 275-gallon AST formerly containing diesel fuel located at south exterior of Building B.  
No staining noted.

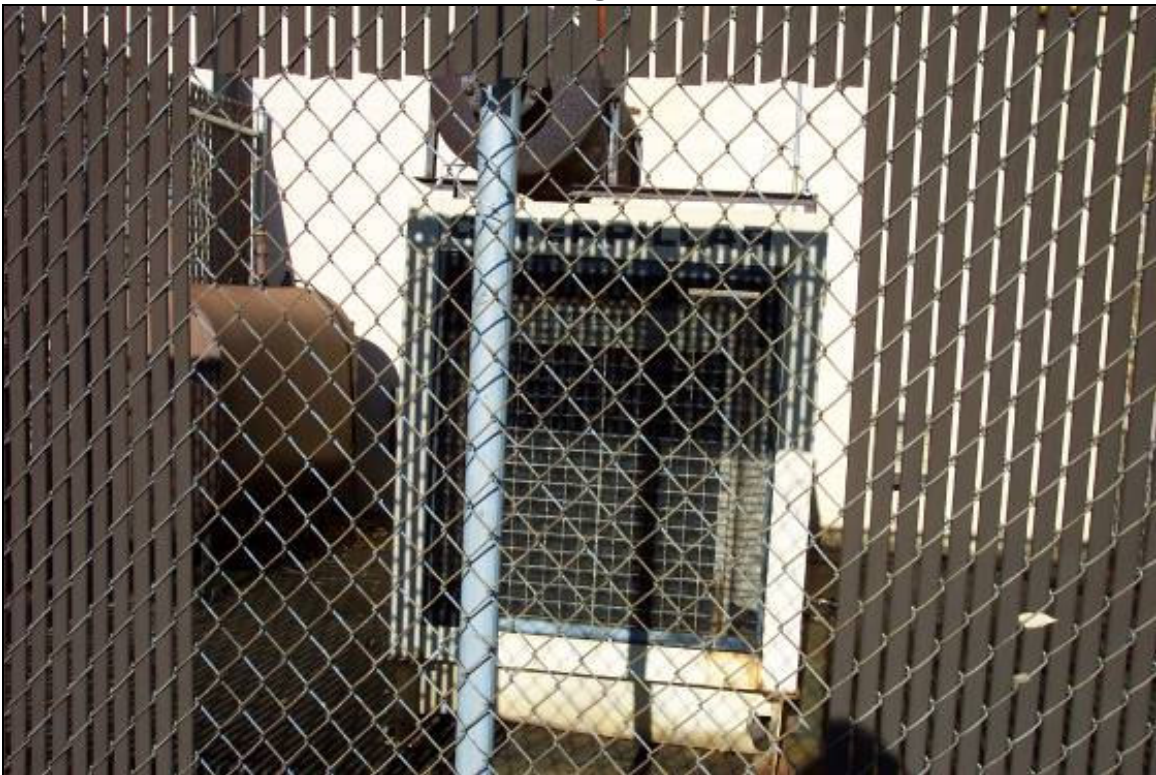
View of emergency generator associated with the 275-gallon AST located at south exterior of Building B

***Above Ground Storage Tanks (AOC-1)*** – One (1) 275-gallon AST which formerly contained diesel fuel and one (1) emergency generator were located at the southwest exterior of Building B. The AST appeared to be in fair condition with no visible staining noted. The AST and generator are located on a concrete slab surrounded by asphalt. CMX recommends no investigation of this AOC.

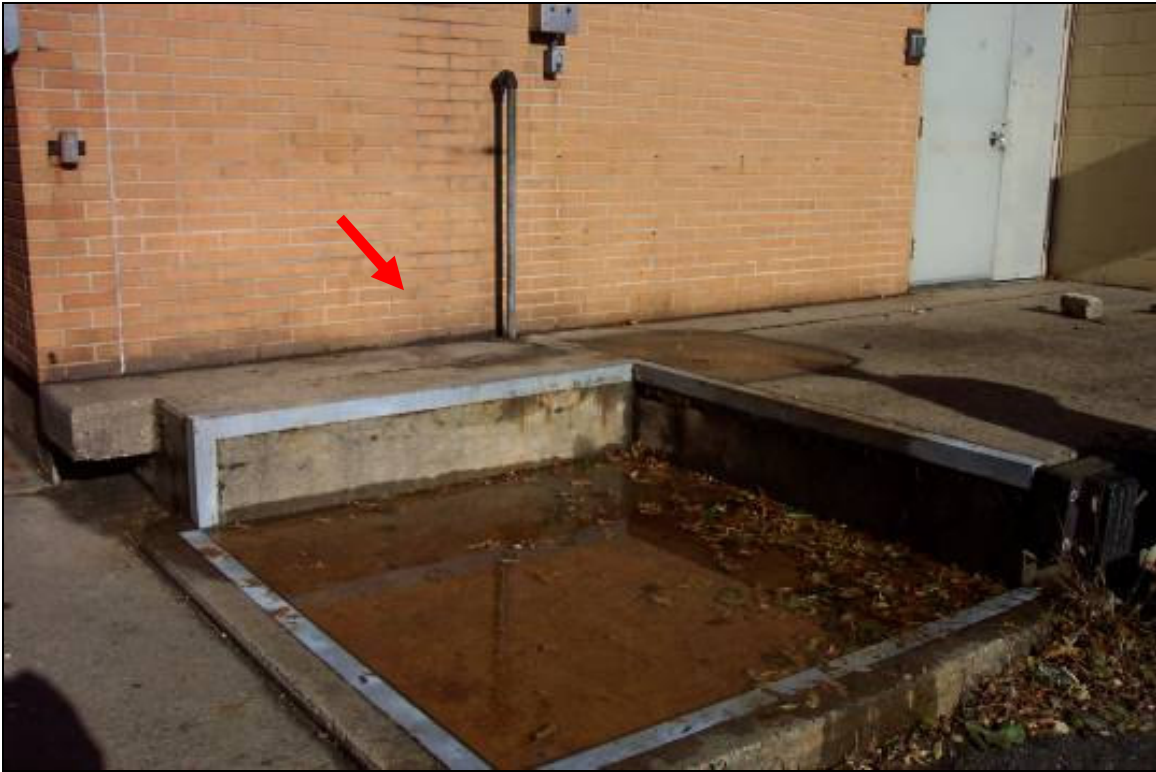
A concrete pad that formerly contained an aboveground hydraulic lift was observed in the loading dock area at the southern side of Building 6/B. No evidence of a discharge from the hydraulic lift system was noted during CMX's 2008, PA inspection. The property owner at the time (Mr. Manco) indicated that the hydraulic lift system tank was removed on November 9, 2007. He also stated that the entire lift was encased within concrete. Mr. Manco provided a Casie Protank Environmental Services non-hazardous manifest and a daily labor/equipment time report which documented the hydraulic lift system pump out and tank removal activities.

View of the former location of above ground hydraulic oil tank and former lift located at the dock of Building B

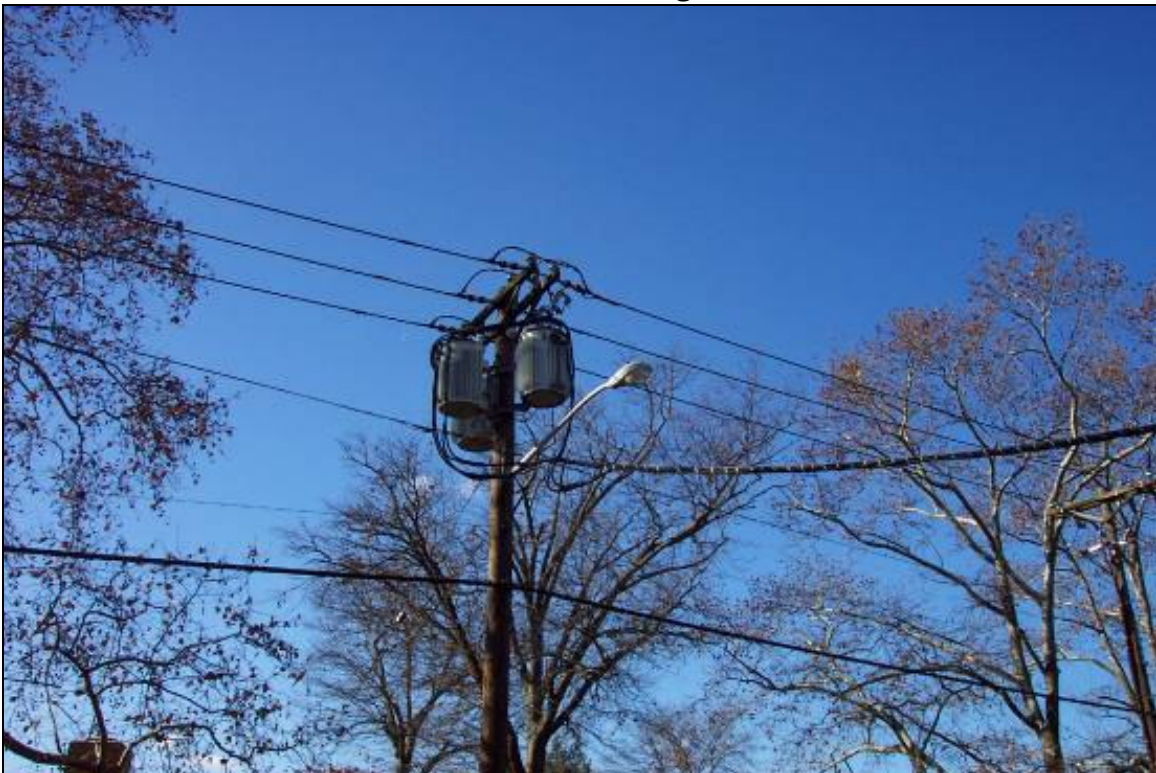
View of pole mounted electric transformer located along Davis Street adjacent to Camden Laboratories. No leaking or staining observed.

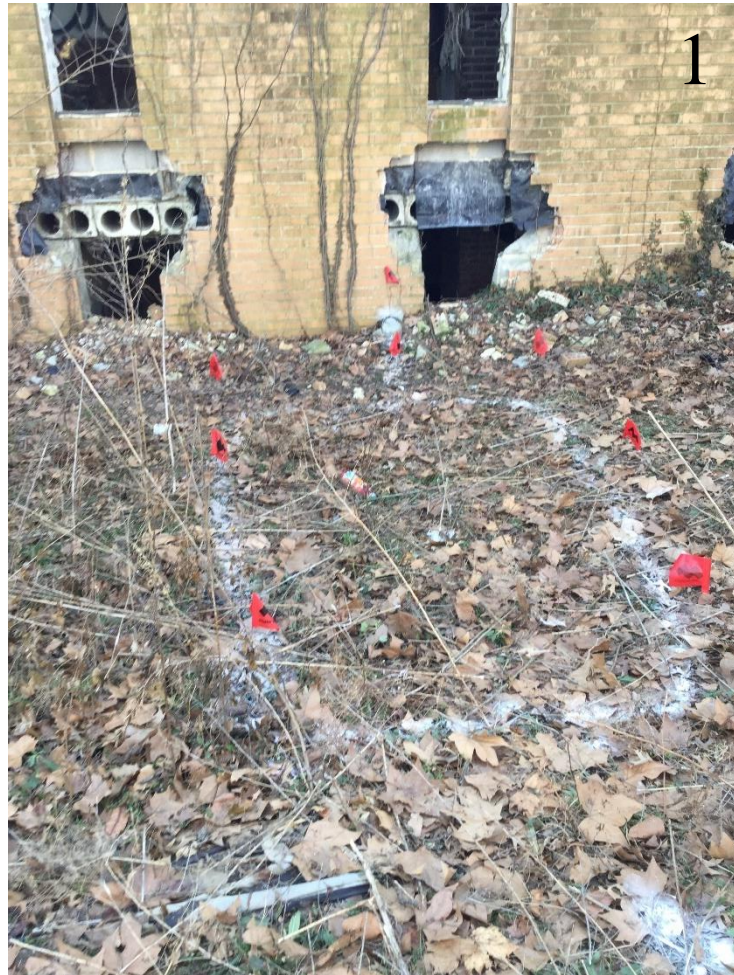
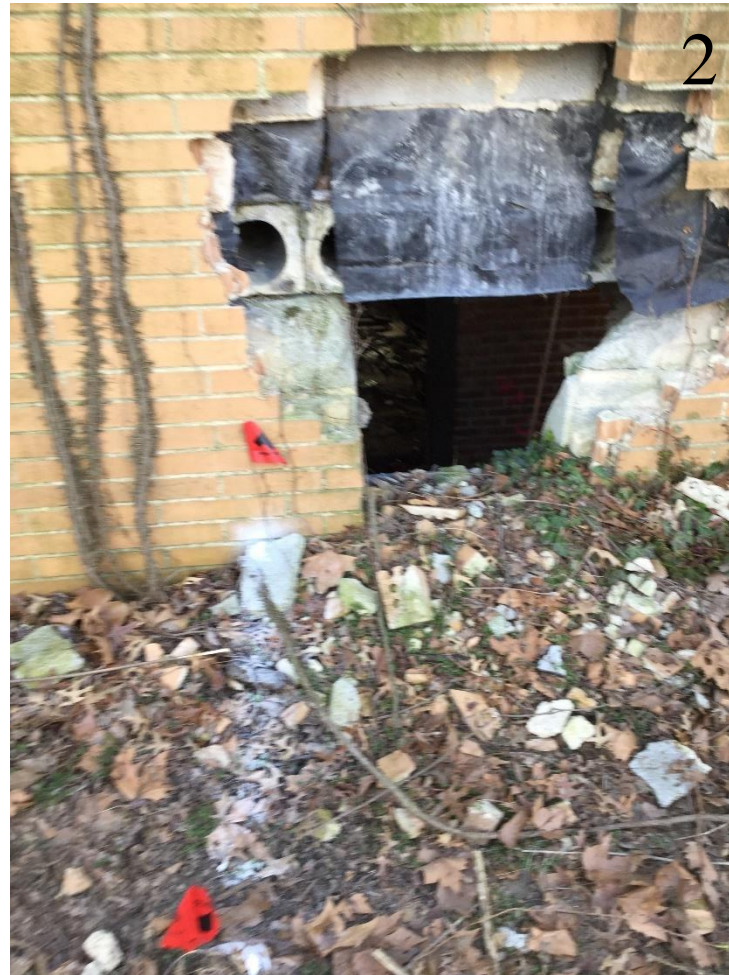
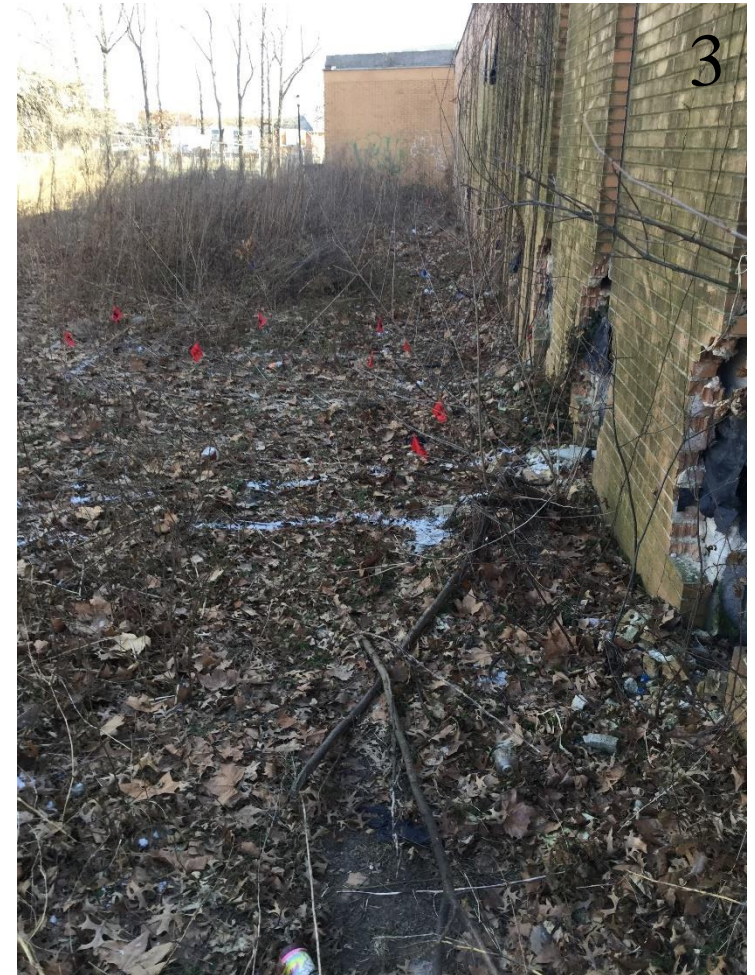
Photo 1: Direction SW, possible UST with unknown linear feature (possible UST associated piping) leading into building  
Photo 2: Direction SW, unknown linear feature leading into building.  
Photo 3: Direction SSE, possible UST with unknown linear feature (possible UST associated piping) leading into buildin
