**REMEDIAL  
INVESTIGATION  
REPORT AND REMDIAL  
ACTION WORK PLAN**

Former Camden Laboratories  
Property

1667 Davis Street  
City of Camden  
Camden County, New Jersey  
Block 1392  
Lot 33

0230198.01  
Camden Redevelopment  
Agency  
October 2019

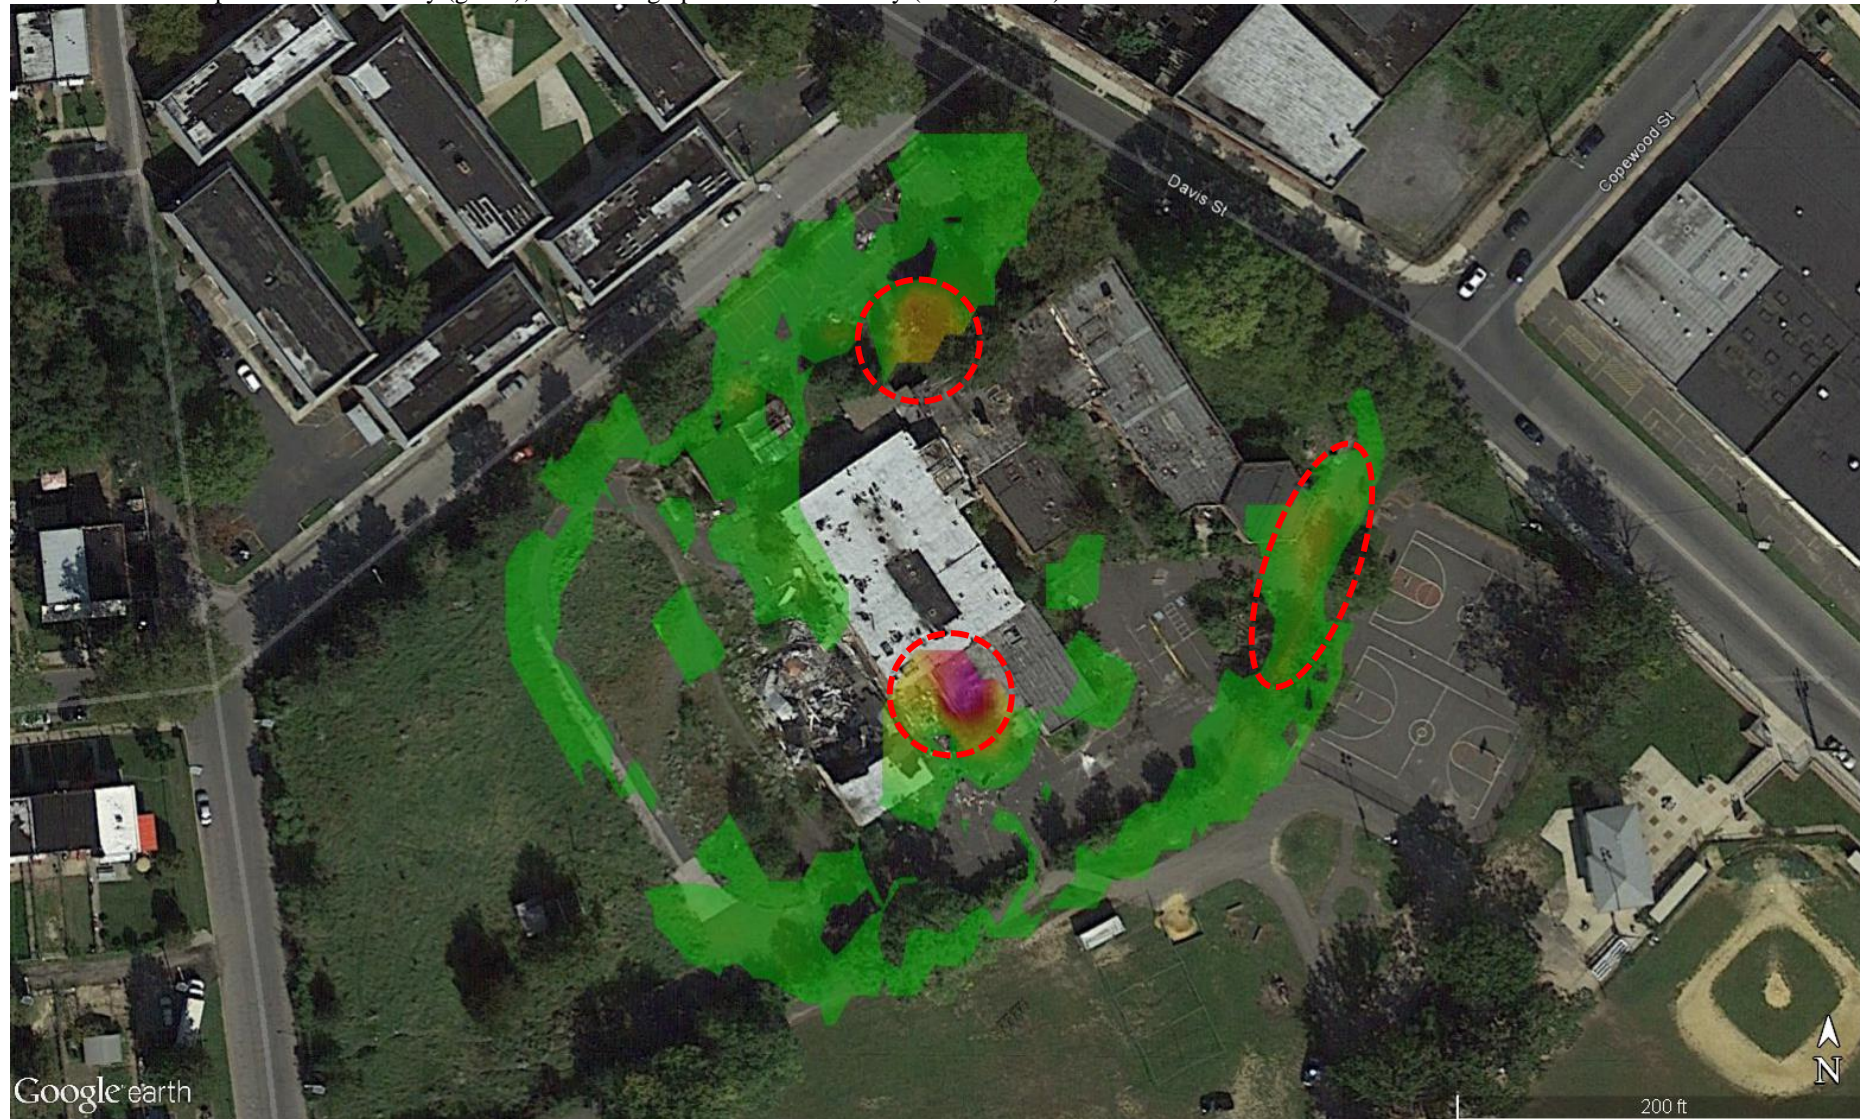
Conductivity[100InPhase[15000] 2011 Google Imagery  
Areas of near-zero positive conductivity (green), areas of high positive conductivity (warm colors)

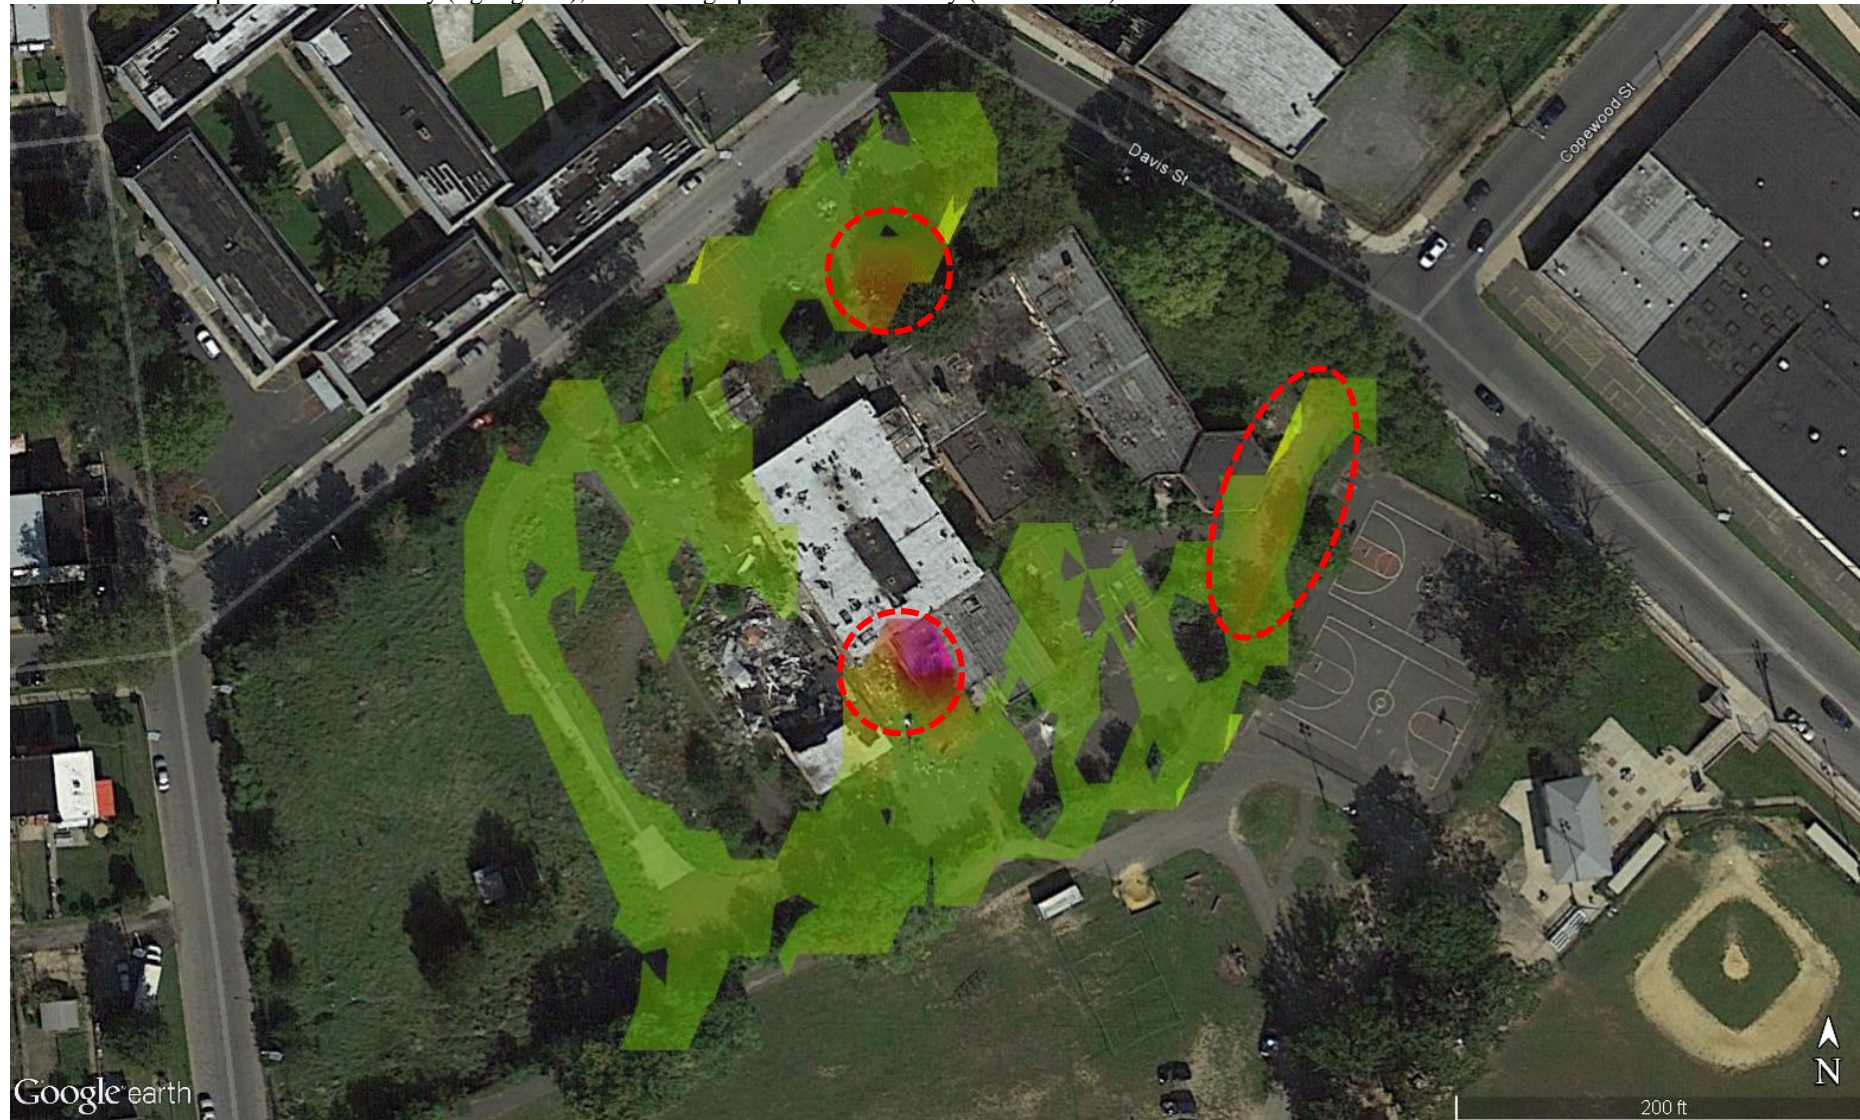
Conductivity[500InPhase[10000] 2011 Google Imagery  
Areas of near-zero positive conductivity (light green), areas of high positive conductivity (warm colors)

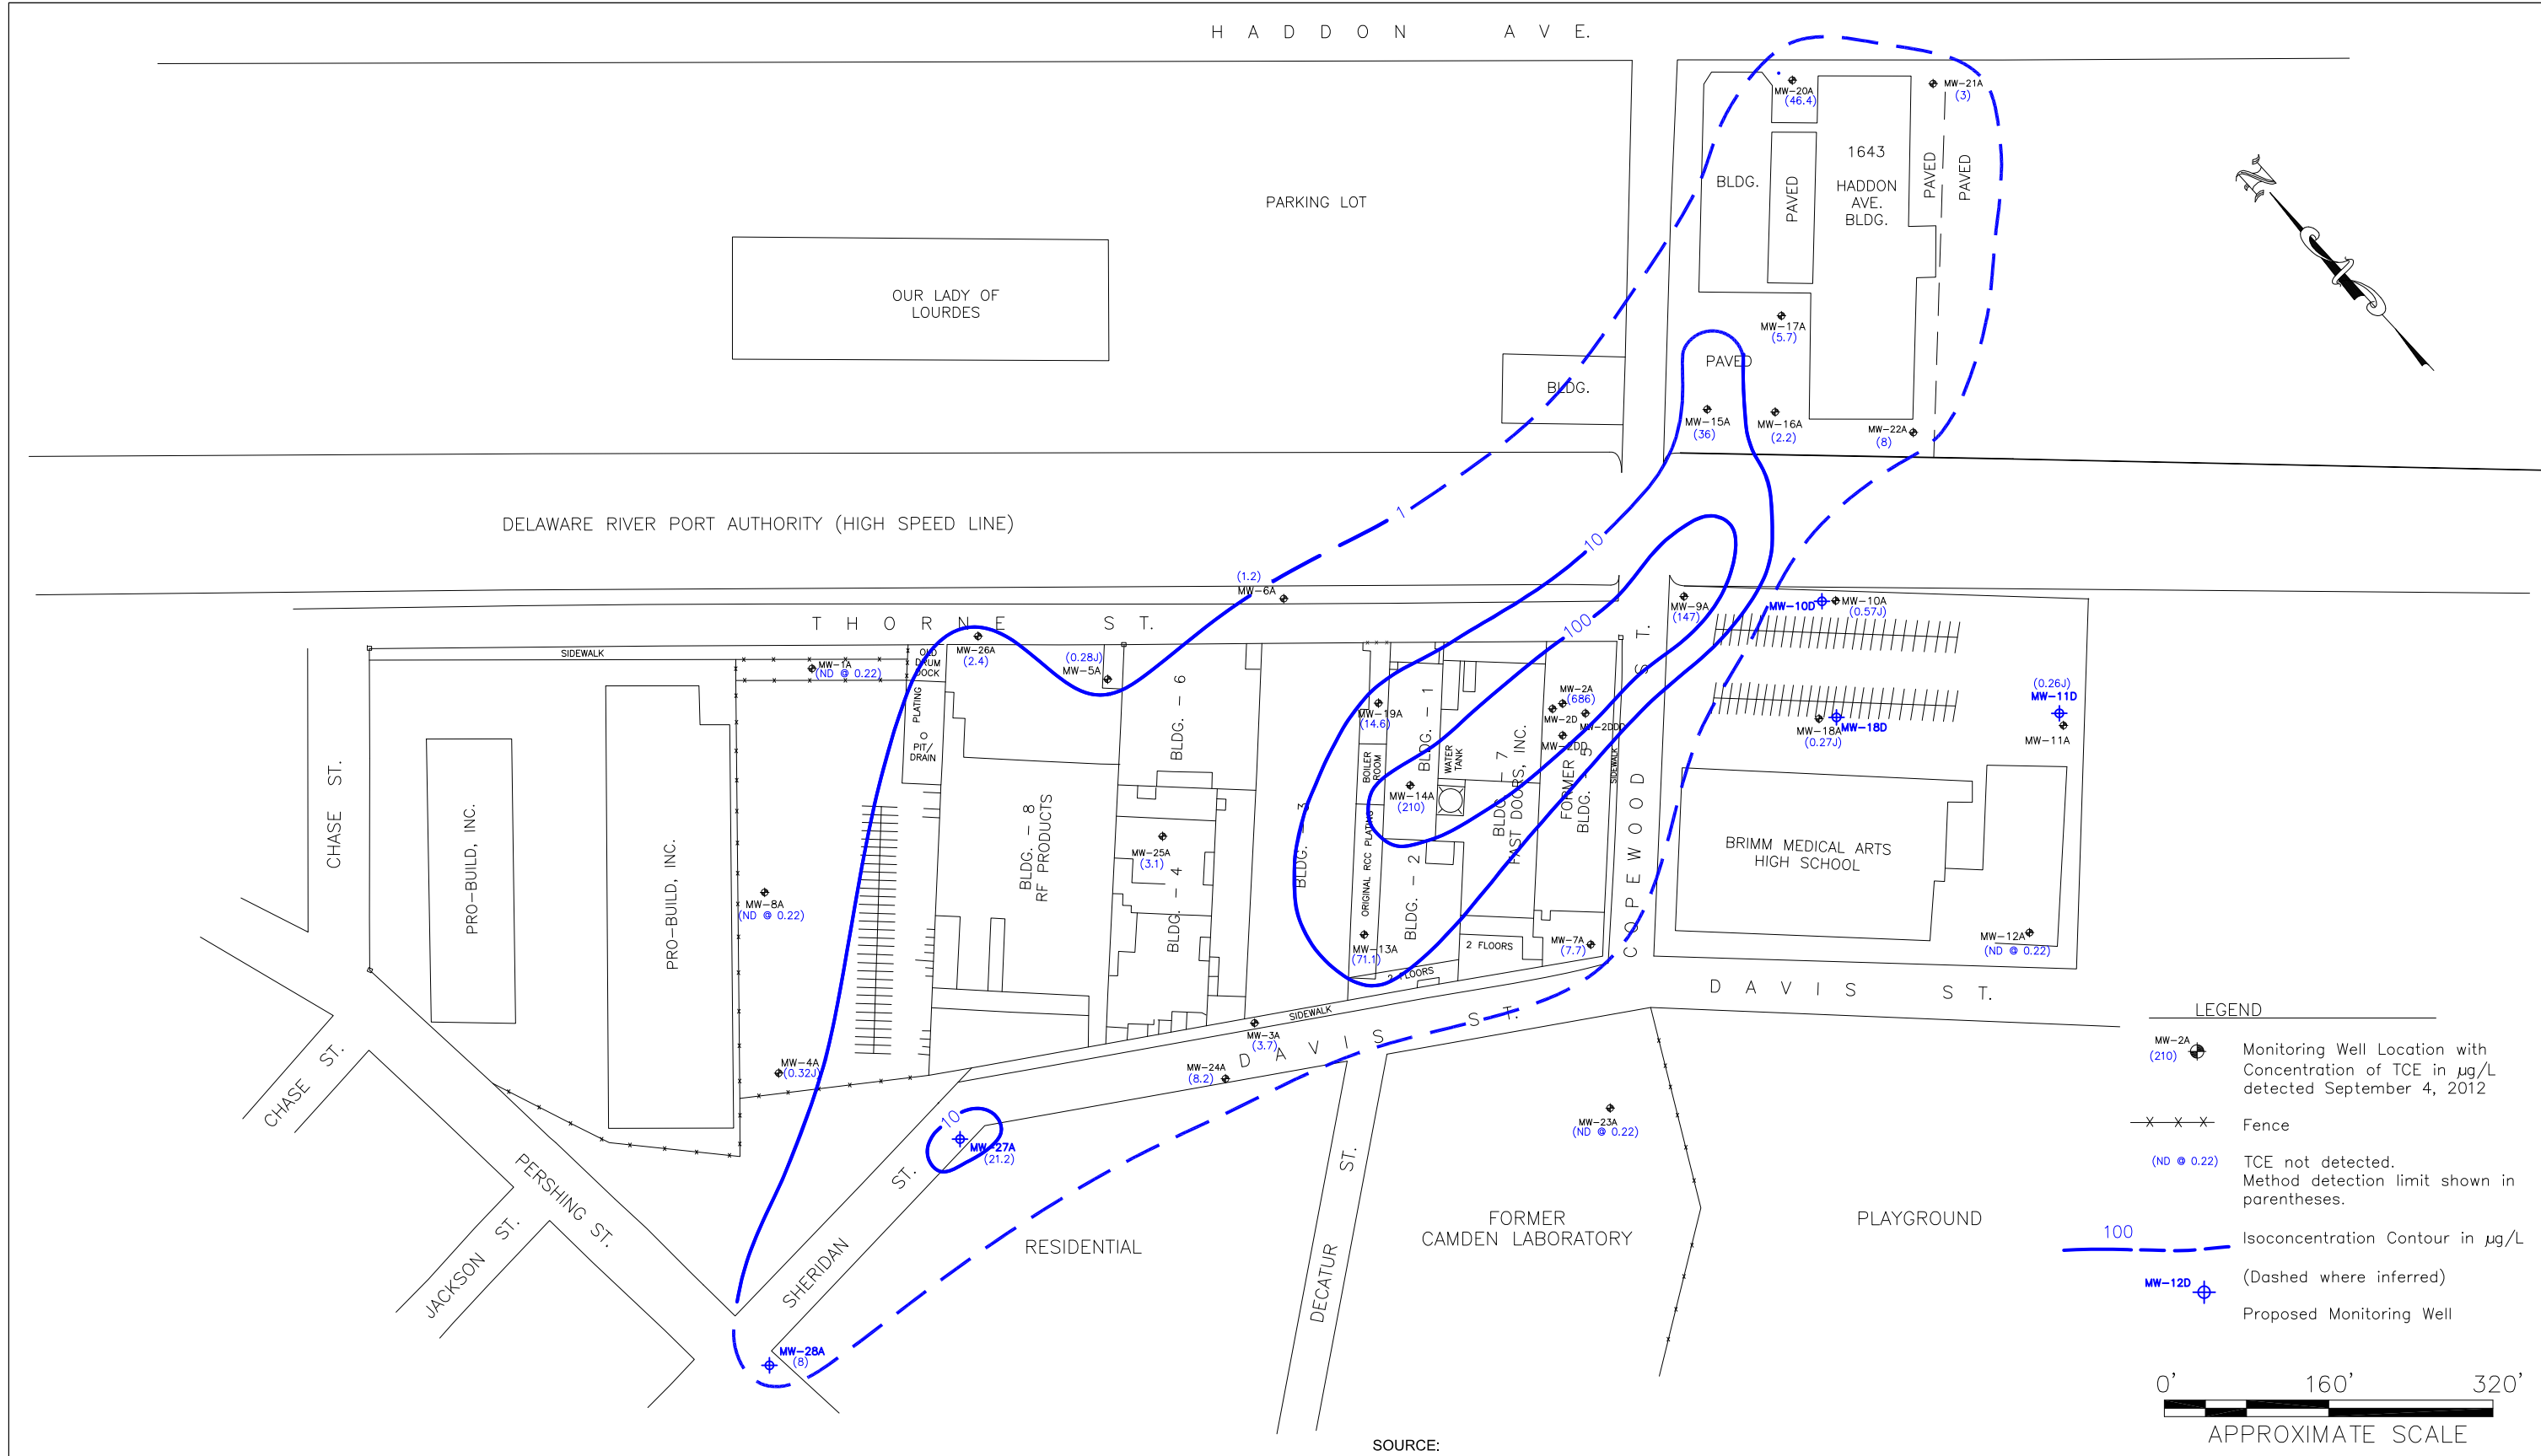
- MW-2A (210) Monitoring Well Location with Concentration of TCE in  $\mu\text{g/L}$  detected September 4, 2012
- x-x-x- Fence
- (ND @ 0.22) TCE not detected. Method detection limit shown in parentheses.
- 100 Isoconcentration Contour in  $\mu\text{g/L}$  (Dashed where inferred)
- MW-12D Proposed Monitoring Well

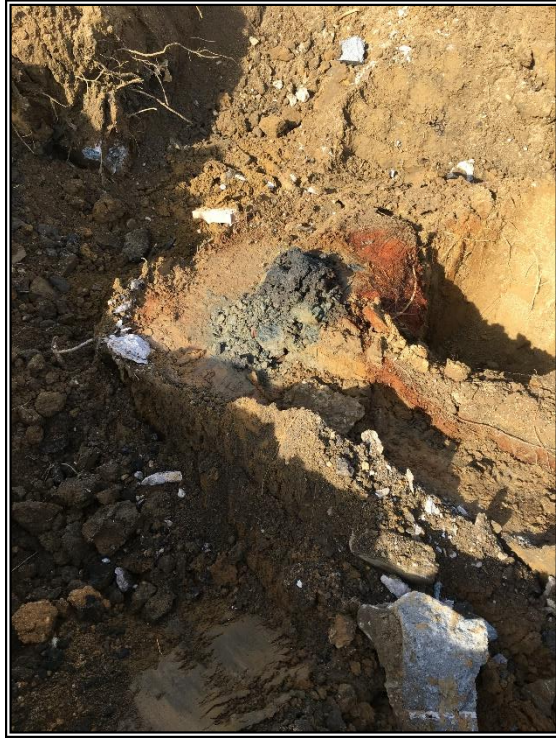
As part of site demolition activities, the hydraulic lift was removed on January 17, 2019. Upon removal, a small area of staining (approximately 1-foot by 1-foot) was observed beneath the concrete structure surrounding the lift; therefore, additional assessments/investigations were conducted in AOC-11 as part of the RI. These investigations and associated findings are presented in Section 5.3 of this report.

*Photo 9: Hydraulic Pit – Soil Staining*
